A DURABILITY TEST OF WOOD POSTS IN HAWAII... third progress report

Roger G. Skolmen

USDA Forest Service
Research Note PSW-260
1971

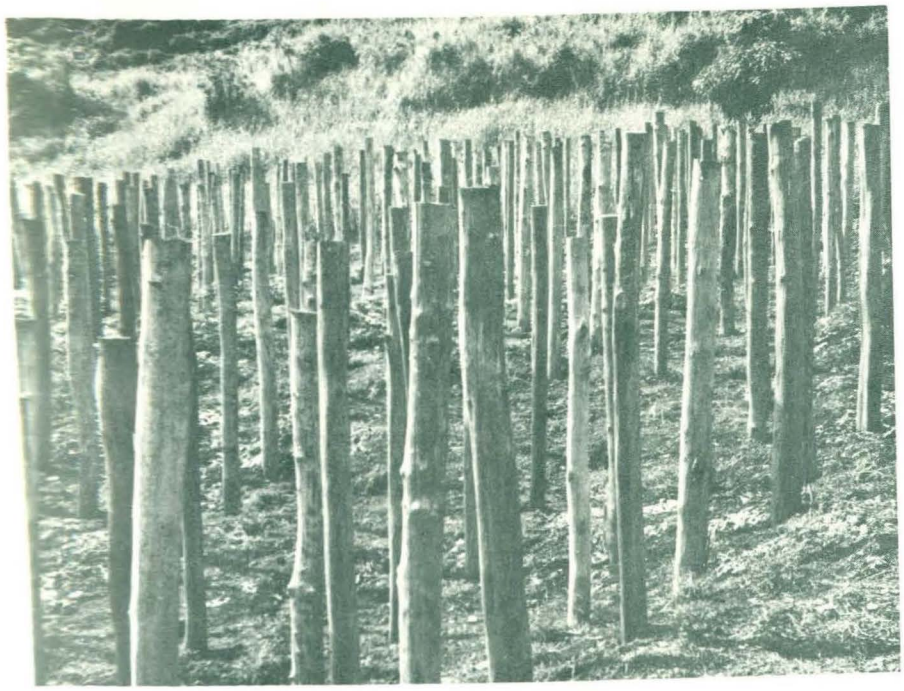
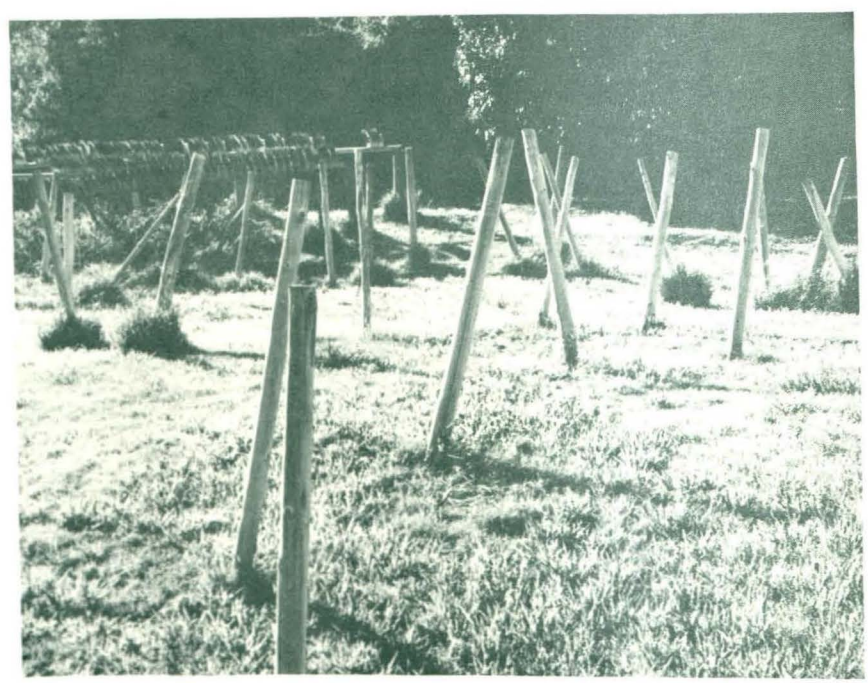
Round posts of 10 Hawaii-grown species were set up in Makiki Valley, Honolulu, in 1961, top. *Some posts had been treated with copper chromate-copper arsenate by the double-diffusion process. After 10 years,* bottom, *only a few posts remain. The missing posts broke off at ground level from decay or termite attacks, and were removed. Another wood durability test underway is shown in the background.*
